CASE STUDY

COLD REFRACTORY DOWN INSPECTION

Metpump® C-190 G and AZS 20
Furnace Cold Repaired 9/2014

Campaign Life: 9 Years, One Month

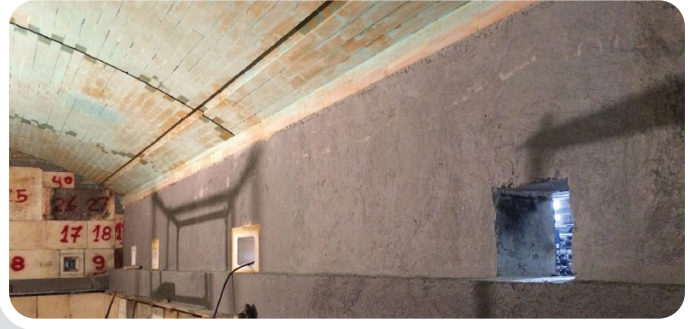
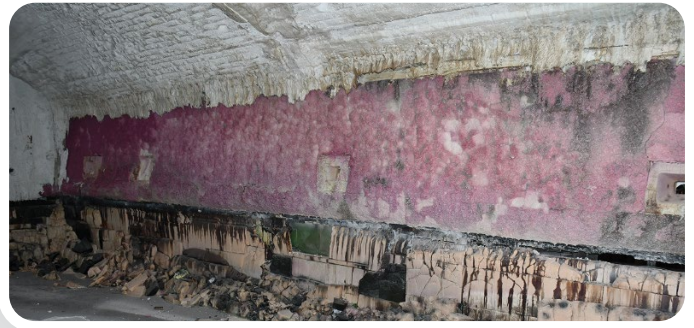
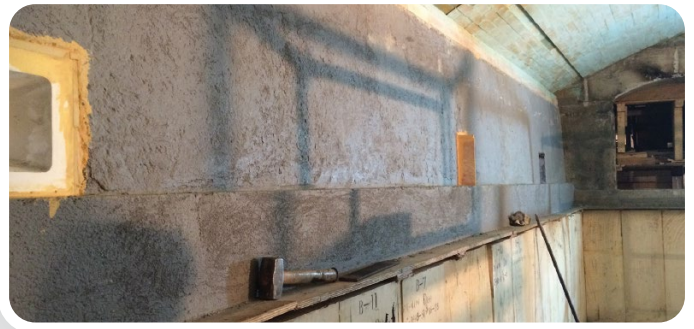
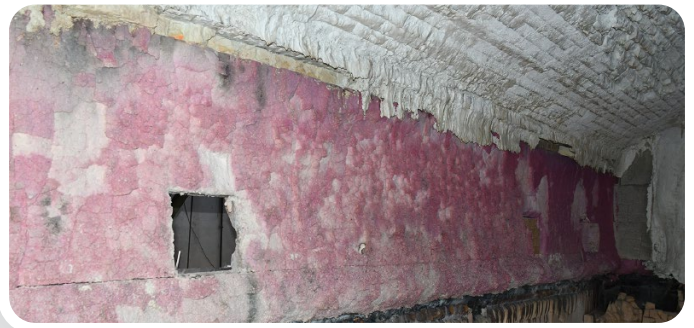
MetPump® replaced traditional refractory for regenerator upper, side and port walls, ports, melter sub bottom, and melter upperstructure breastwalls and port endwall.

Upper Side Walls	Monolithic	C-190 G
Target Walls	Monolithic	C-190 G
Port Walls	Monolithic	C-190 G
Ports	Monolithic	AZS 20
Sub Bottom	Monolithic	C-190 G
Breast Walls	Monolithic	C-190 G
Port End Walls	Monolithic	AZS 20

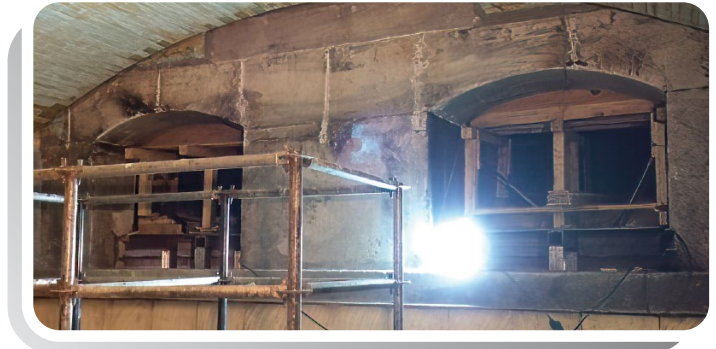
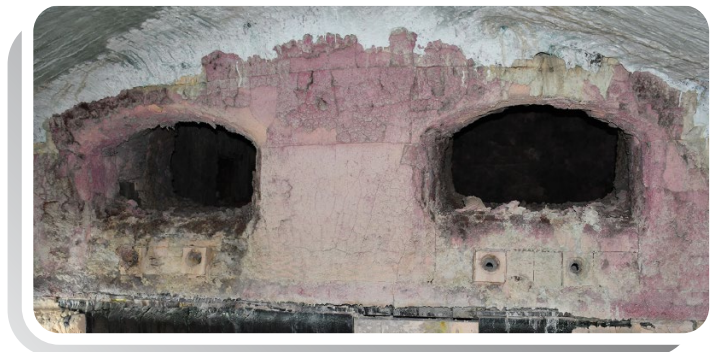
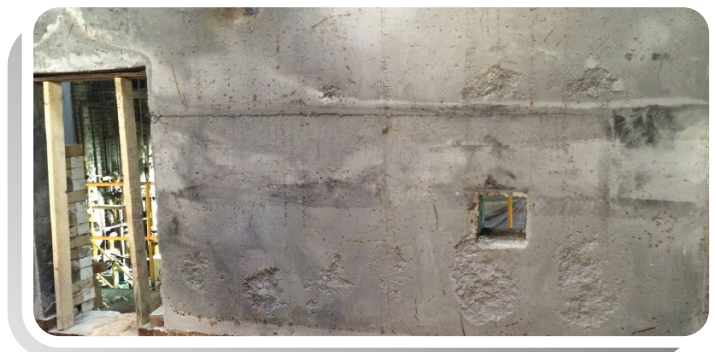
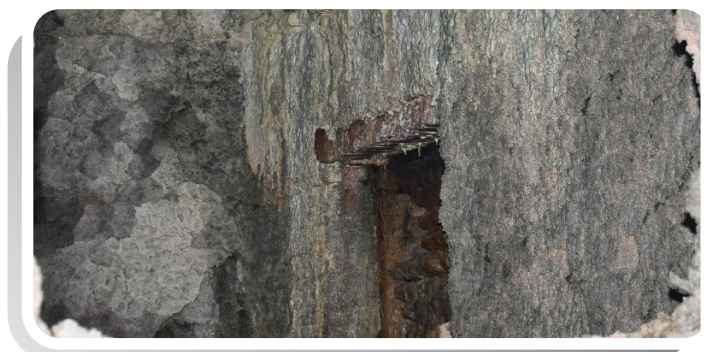
- Tuckstone line in place, no broken noses
- Overall wall thickness remain at 50%-80%
- No ratholes, no bowing
- Overall wall condition in good shape
- Doghouse upperstructure still in place
- Doghouse arch made in fused cast blocks collapsed during campaign

- Tuckstone line in place, no broken noses
- Overall wall thickness remain at 70%
- No ratholes, wall sound/stable, no bowing
- Overall wall condition pretty good shape

- Sidewalls in good condition, no holes or spalled surface
- Crowns in good condition

- Good condition, overall thickness is good, no holes or hot spots from the outside

- Full thickness, no spalling or lining damage of any kind
